# Ushering in the Digital Era of Proactive Corrosion Management - A-10 ASIP Prognostic Development & Tactical Advantages 30 Nov 23

**Chris McLaughlin**  
AFLCMC/WWA  
DSN: 777-3772  
[christopher.mclaughlin.6@us.af.mil](mailto:christopher.mclaughlin.6@us.af.mil)

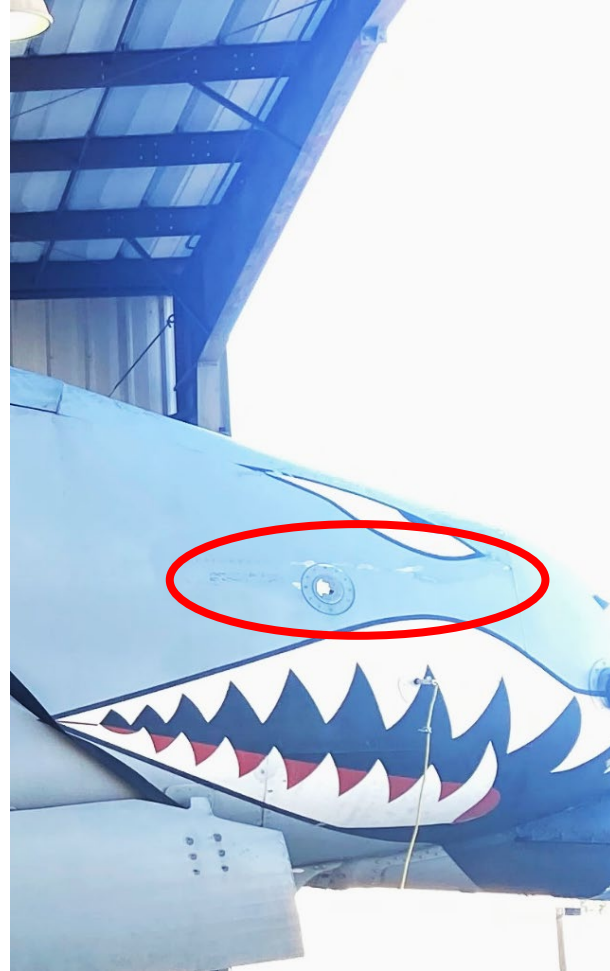
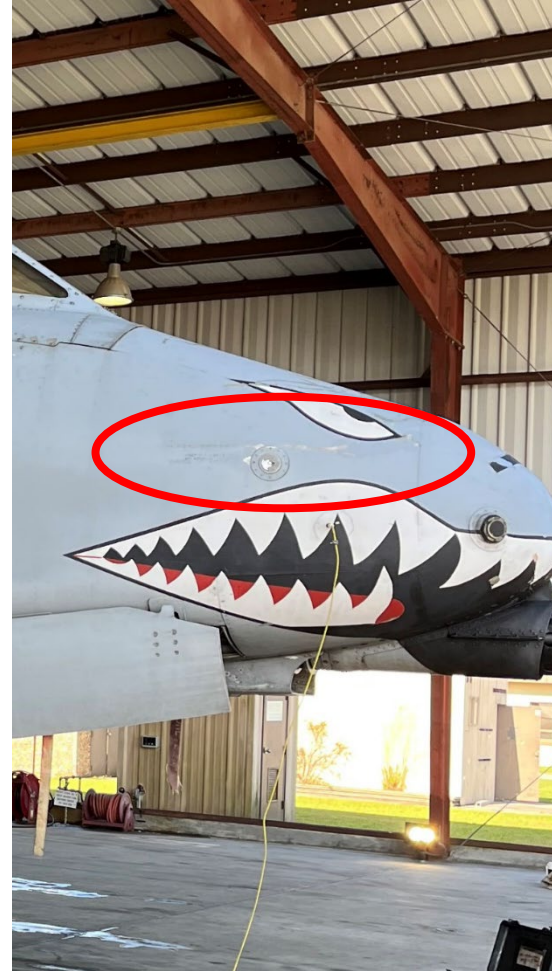
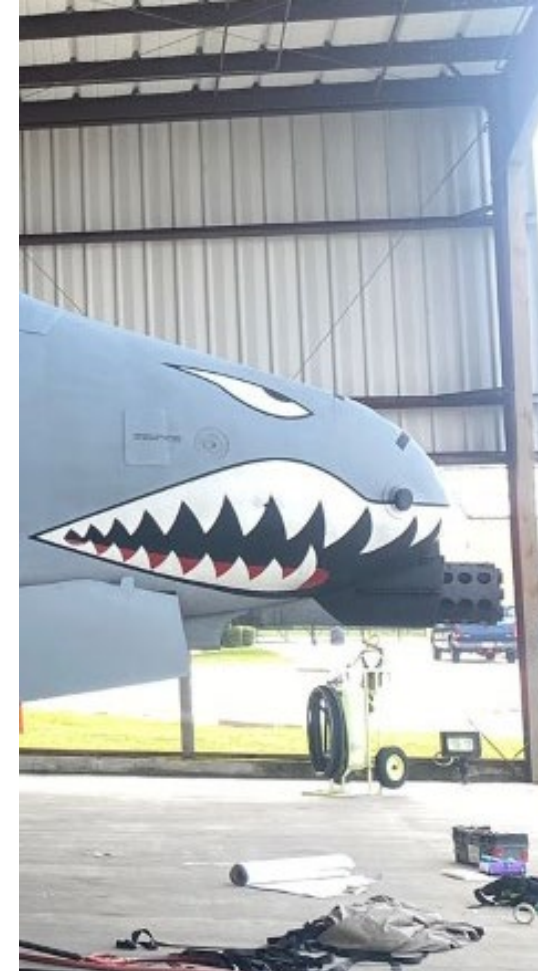
**Pictures from field are instantly uploaded and can be viewed seamlessly by EN**

17 November 2021

25 April 2022

24 August 2022

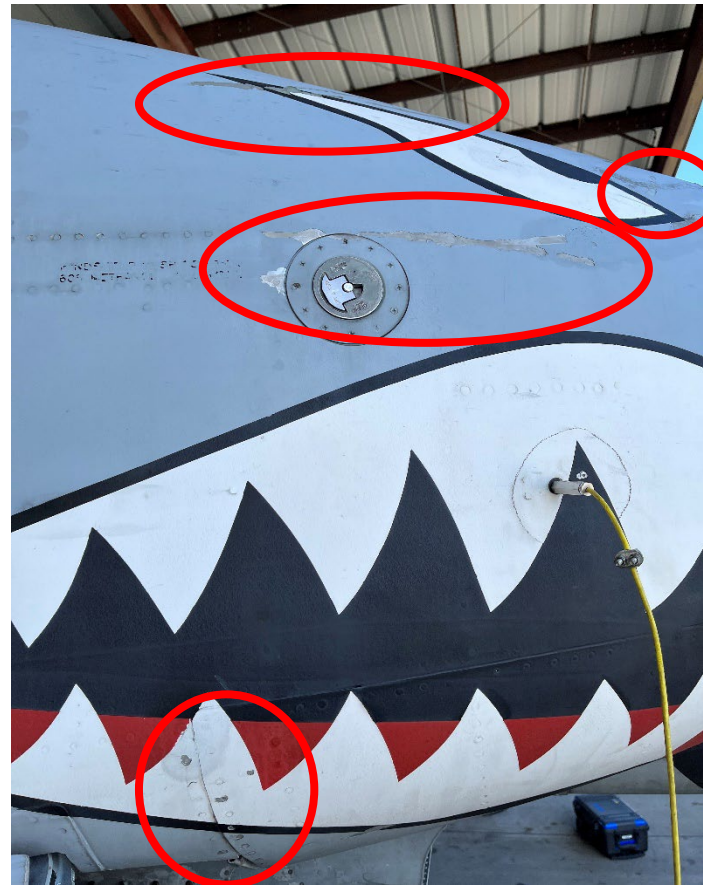
Pictures from the field

**Damages are “mapped” and digitized in the record**

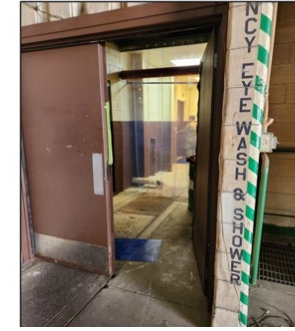
- RAC 5
  - Transition Areas
    - Insufficient transition areas for CCF ops

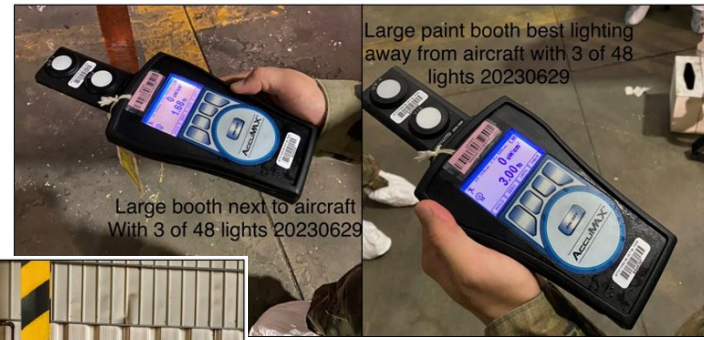
- RAC 6
  - Large Booth Lighting
    - Insufficient light supply for work

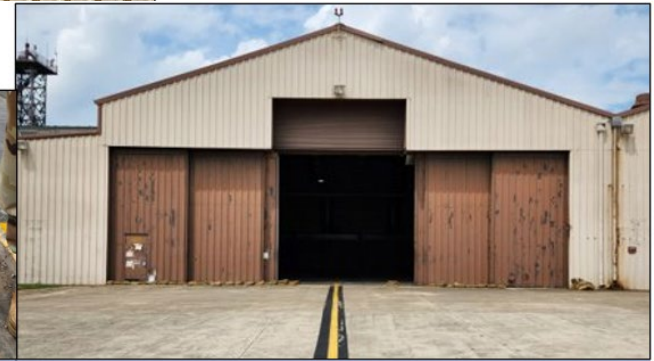
- RAC 8
  - Large Booth Exposed Wiring
    - Combustion hazard from blaster dust and vapors

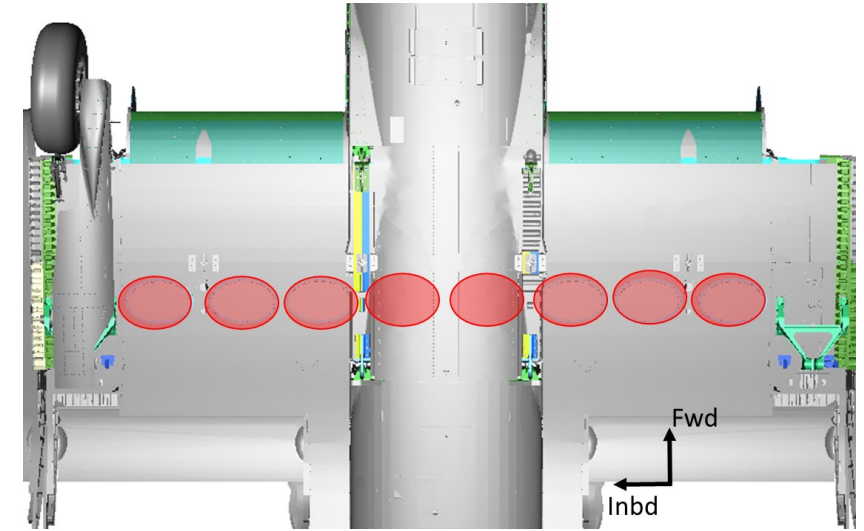
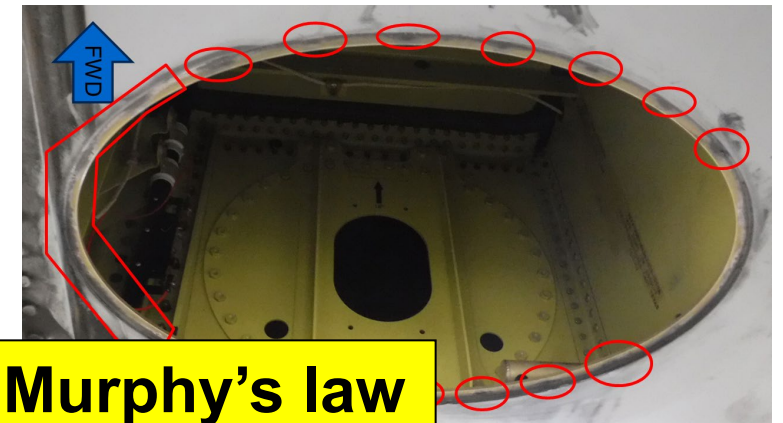
- Enhanced Wing Assembly (EWA)
- Brand new in 2014
- Induction scheduled for Oct 2022
- “It’s a new wing...”
- Research into common corrosion
- 3 of 8 fuel access doors corroded on “new wing...”
- Depot reports 100% corrosion
- Where’s the data?
